**DESIGN PARAMETERS AND TECHNICAL CONDITION OF
HYDROTECHNICAL STRUCTURES IN THE ZOMIN
WATER RESERVOIR**

Abstract. Zomin water reservoir is a seasonally controlled reservoir built on a river bed. It was built on the Zominsoy river, located 8 kilometers from the center of the district, in the Zomin district of the Jizzakh region. The reservoir is designed to irrigate 7,820 hectares of land in Zomin district. In order to study the current technical condition of hydrotechnical facilities in the Zomin water reservoir, natural observation-measurement works were carried out. After checking the technical condition of hydrotechnical structures in the reservoir, it was found that there are the following defects: on the upper slope of the dam, from the scythe to the berm, at the mark 916.0 m., no deformation and damage was detected, at the mark 916.0 m, the subsidence of the berm from PK4-00 to PK5÷16 is visible, the covering plates are cracked, at the bottom there are gaps. When built according to the project, they will be 600m. At the 902 m mark, the entire berm was repaired and part of the lower slope was repaired with an area of 1566 m². In the area of marks 902-909 m, between the marks

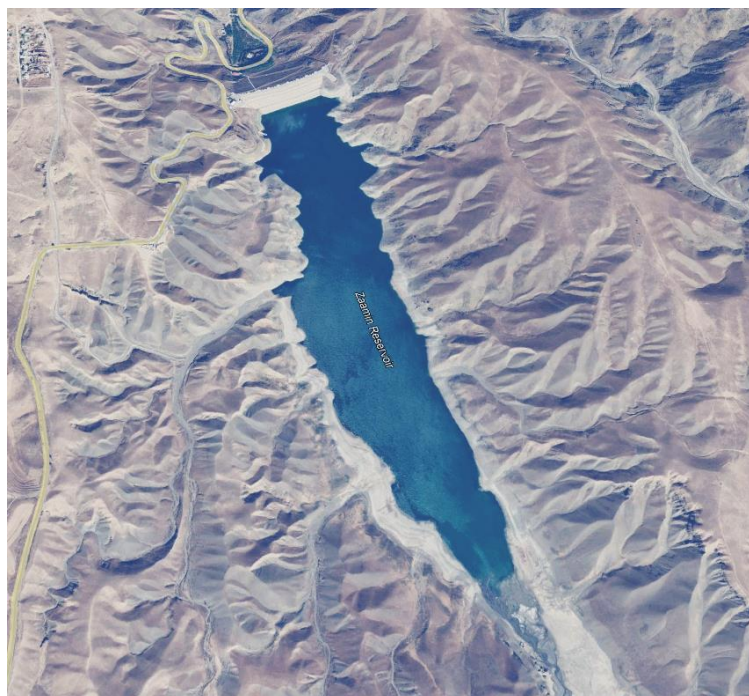
Figure 1. Zomin Reservoir (Google Earth)

Construction of one of such reservoirs - Zomin water reservoir was carried out in 1975-1987. It was commissioned in 1987. The Zomin water reservoir is a seasonally managed water reservoir built in the river bed, located on the Zominsoy River, located 8 kilometers from the district center, in the Zomin district of the Jizzakh region. The reservoir is designed to irrigate 7,820 hectares of land in Zomin district. The main design parameters of the reservoir are as follows: normal rest water level (NDS) of the reservoir - 917.0 m, emergency (maximum) rest water level MDS 924.75 m, useless volume satx FXS -873.0 m, full volume at the NDS mark 34,52 mln.m³, full volume in MDS is 51.00 mln.m³, useless volume is 1.1 mln.m³, the deepest part of the reservoir is 73.0m, the surface of the reservoir in NDS is 1.4 km, the largest water carrying capacity : 60 m³/s for water outlet, 250 m³/s for catastrophic water discharge facility. The water reservoir includes the following structures: a dam, a water outlet, a catastrophic (emergency) water discharge facility, a water-carrying channel, a water-carrying trough.
